Guidelines for Using Composite Materials to Repair High Pressure Transmission

Prepared for
**Dominion
Energy**

Project No. DOM-17-018

May 2018

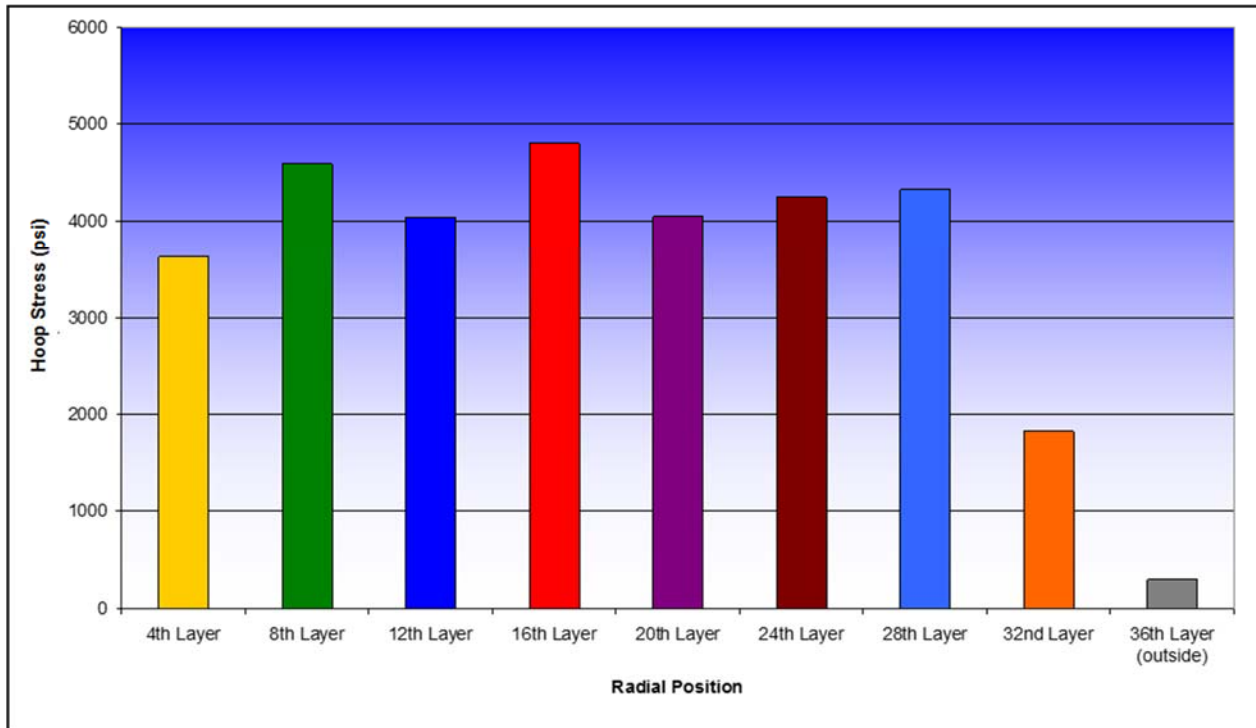
Figure 4-4: System #1 Hoop Strain at 72% SMYS (Function of Radial Position)
(Hoop stress calculated as the product of the measured strain and the composite's elastic modulus)

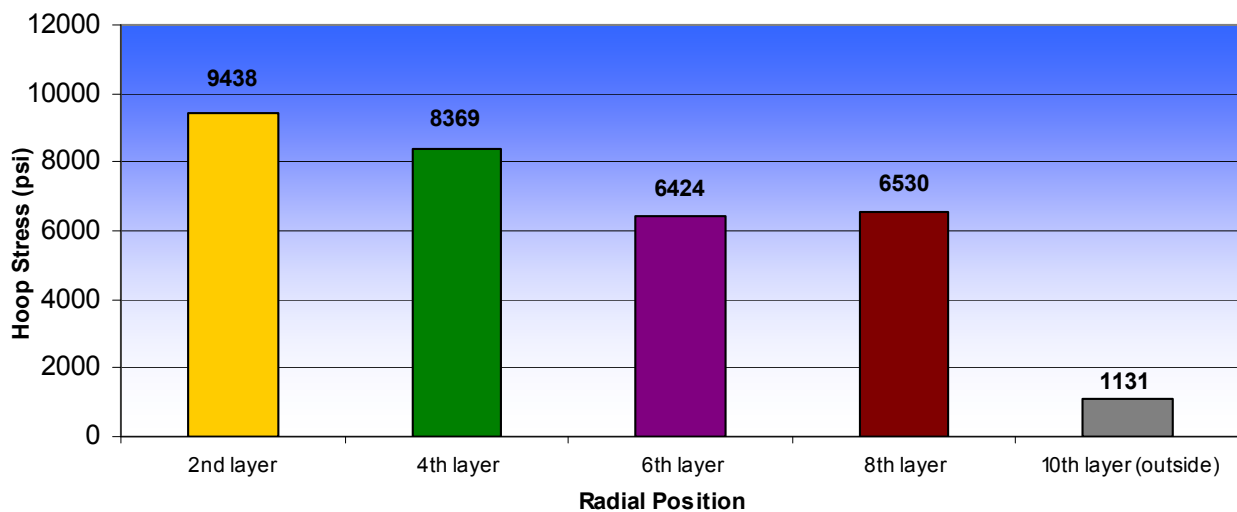
Figure 4-5: System #1 Hoop Strain at 72% SMYS (Function of Radial Position)
(Hoop stress calculated as the product of the measured strain and the composite's elastic modulus)

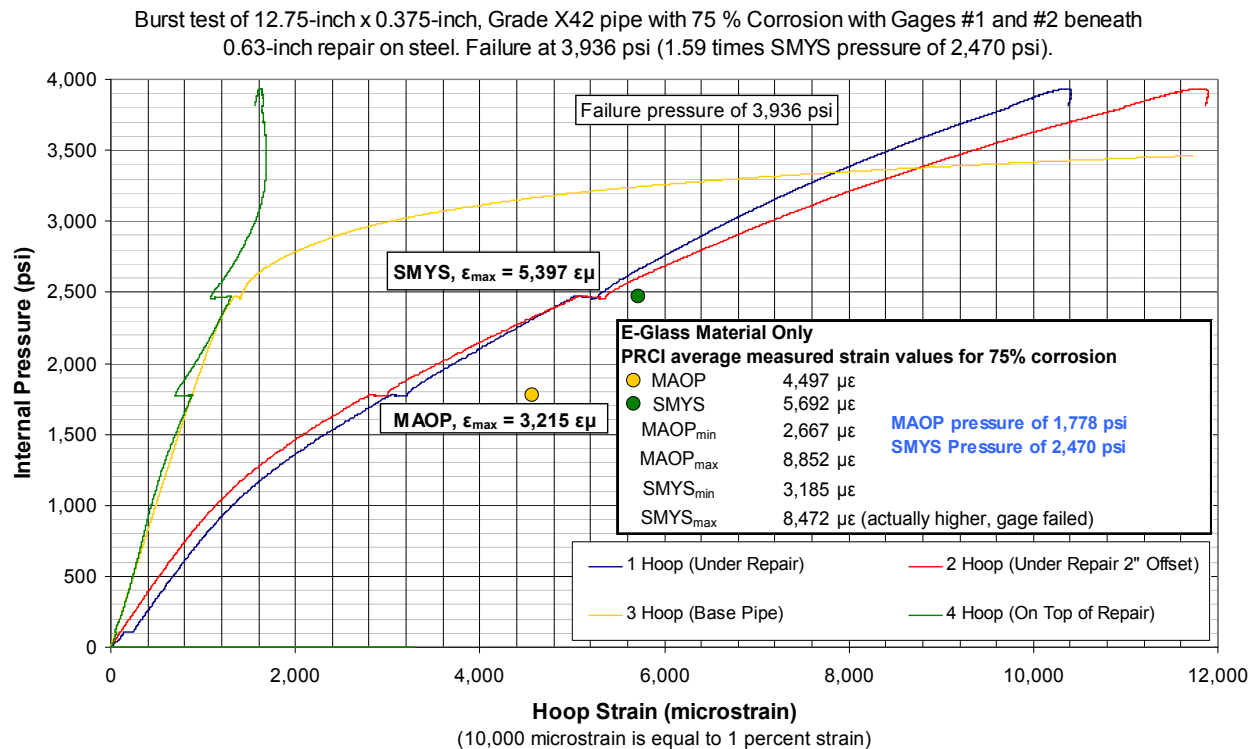
Figure 4-6: Measurement of strain in 75% corroded region for System #2

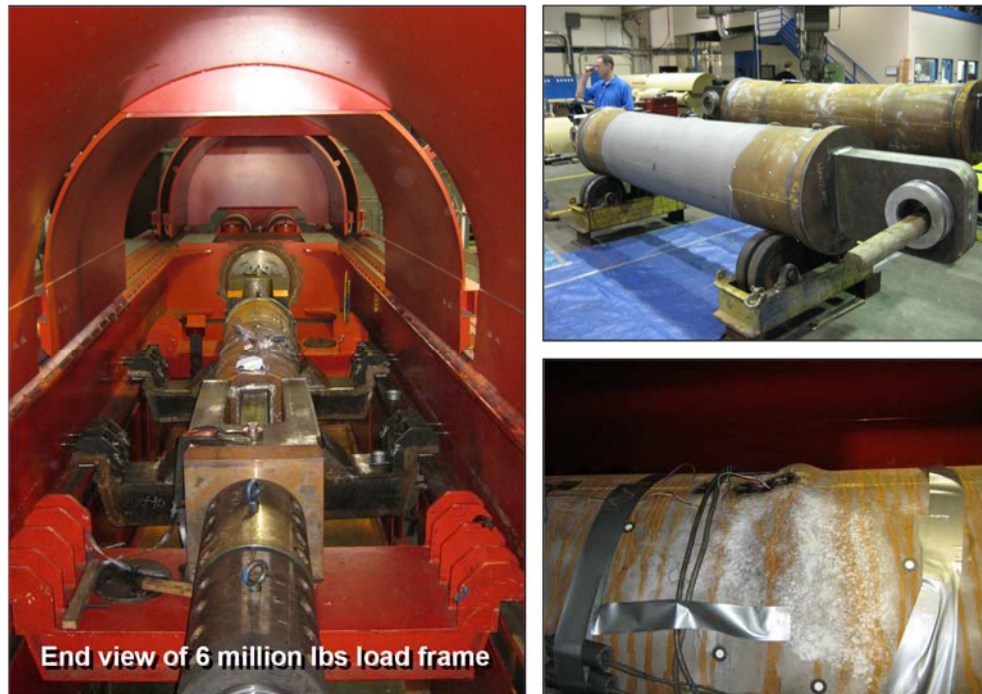
Figure 4-7: Photographs showing testing set-up for wrinkle bend testing

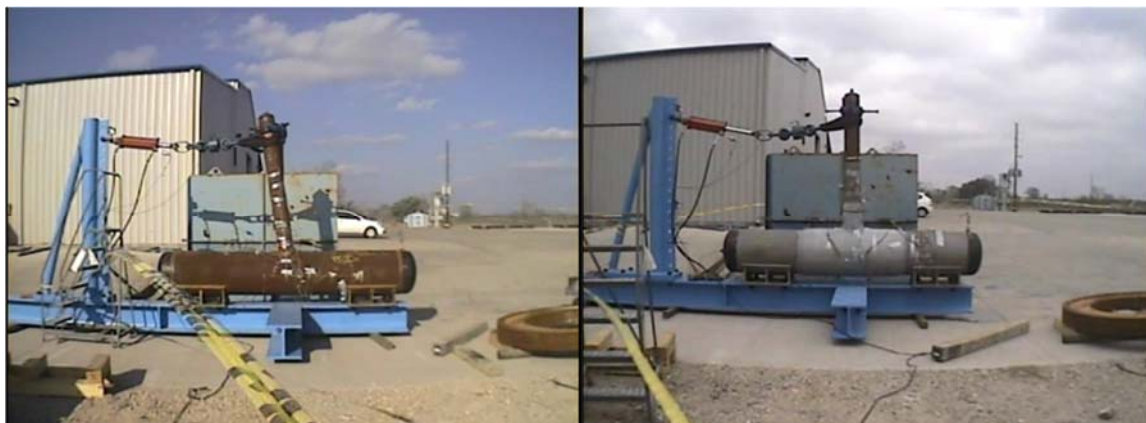
Final displacements for in-plane unreinforced (left) and reinforced (right) bending tests

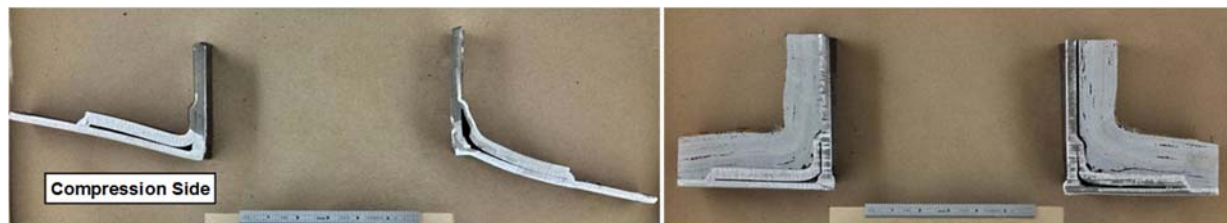
Unreinforced In-plane Sample
(after 13.3 inches displacement at 88.6 kip-feet bending)

Reinforced In-plane Sample
(after 4.7 inches displacement at 124.0 kip-feet bending)

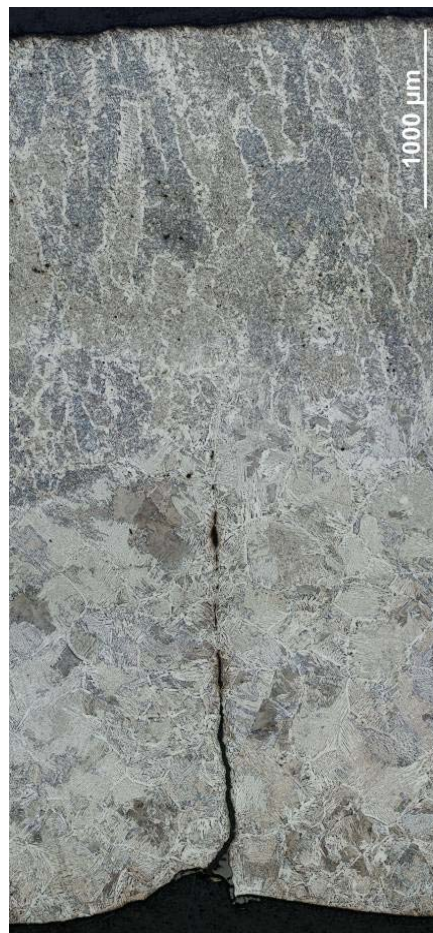
Figure 4-12: Metallographic section of the defective girth weld material

Note the discontinuity—a lack of fusion on the ID surface (seen at bottom of photomicrograph).

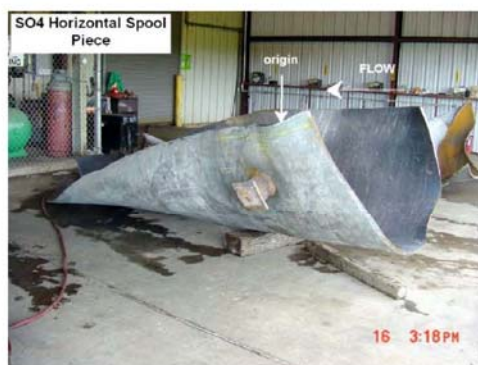
Figure 2: Horizontal spool piece showing fatigue-cracked seam weld

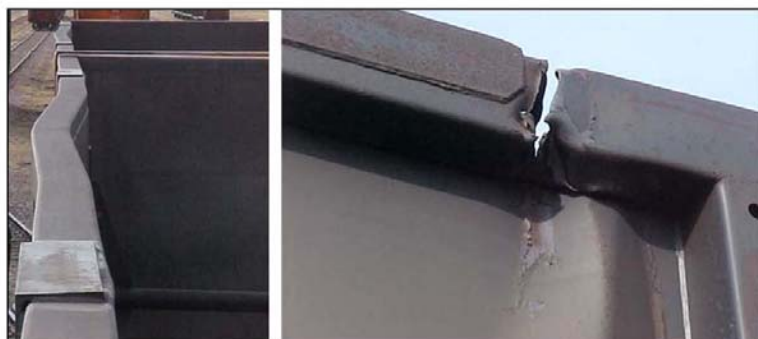
Figure 11: Photographs of buckled top chord and associated fracture

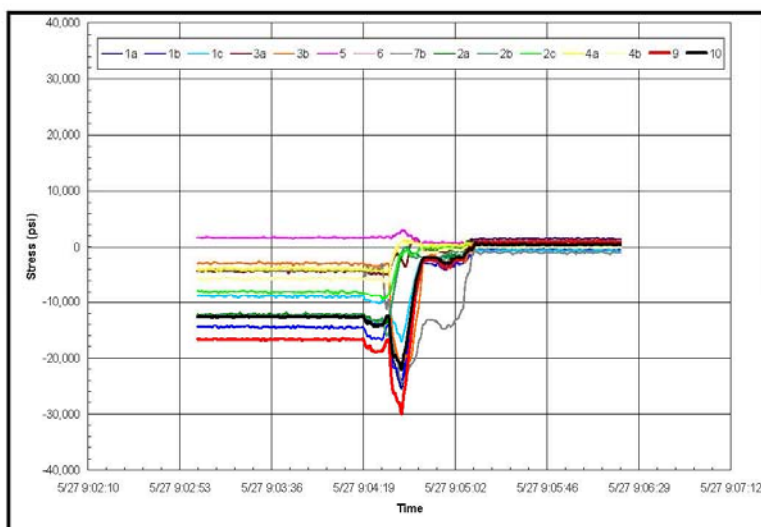
Figure 14: Stress based on strain gage measurements made using on-board data logger

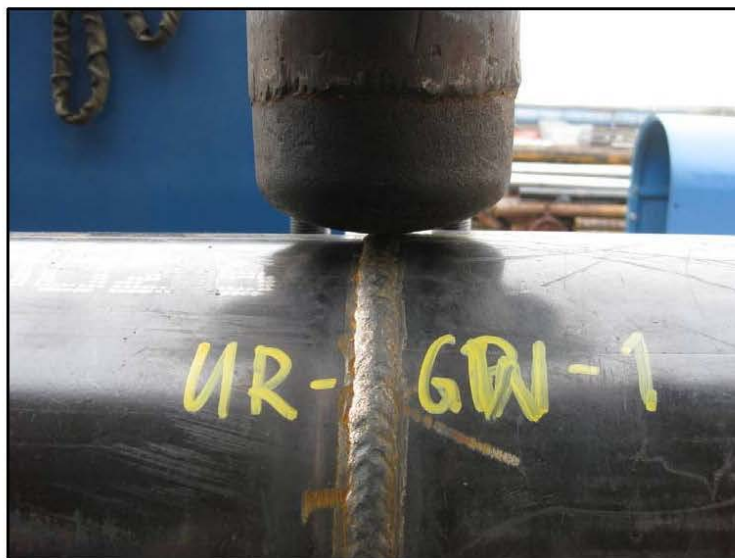
Figure 3 – Close-up view on indenter on girth weld

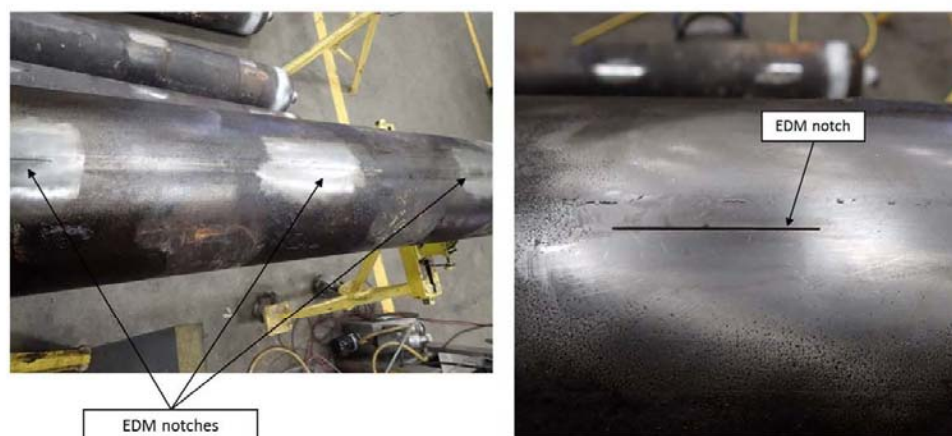
Figure 2: Photographs of EDM Notches

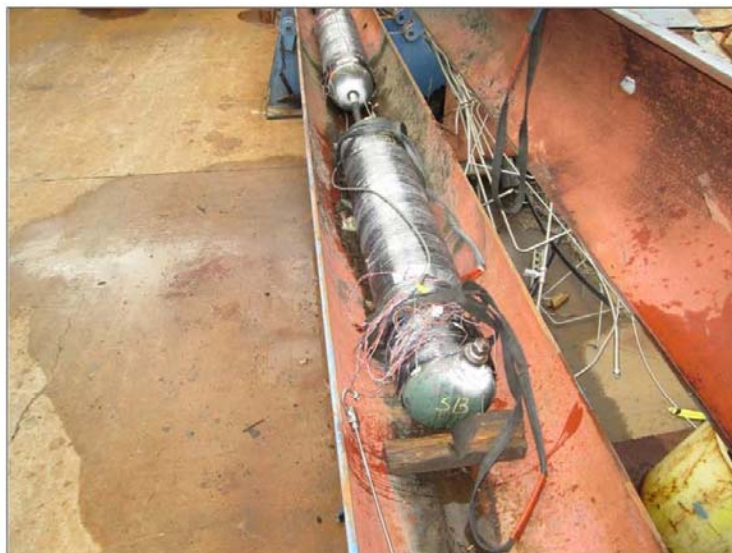
Figure 4: Milliken-Pipe Wrap Atlas System – as Repaired and Set up for Testing

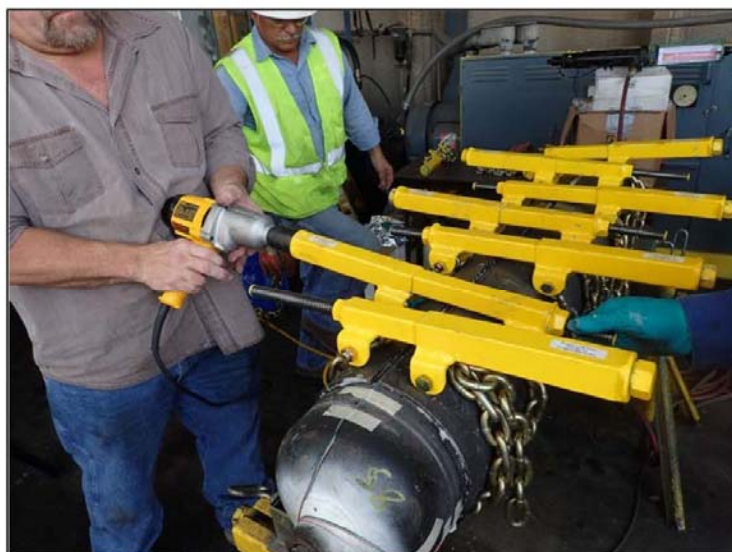
Figure 5: Installation of the Western Specialties ComposiSleeve

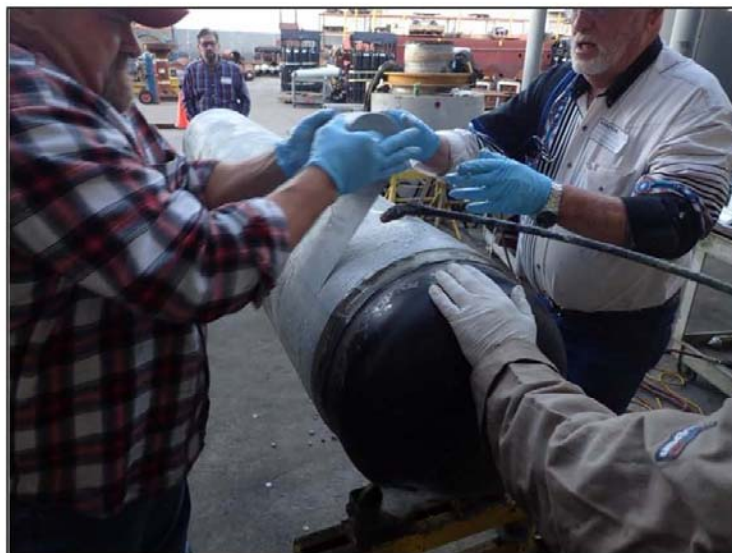
Figure 6: Installation of the Western Specialties ComposiSleeve System

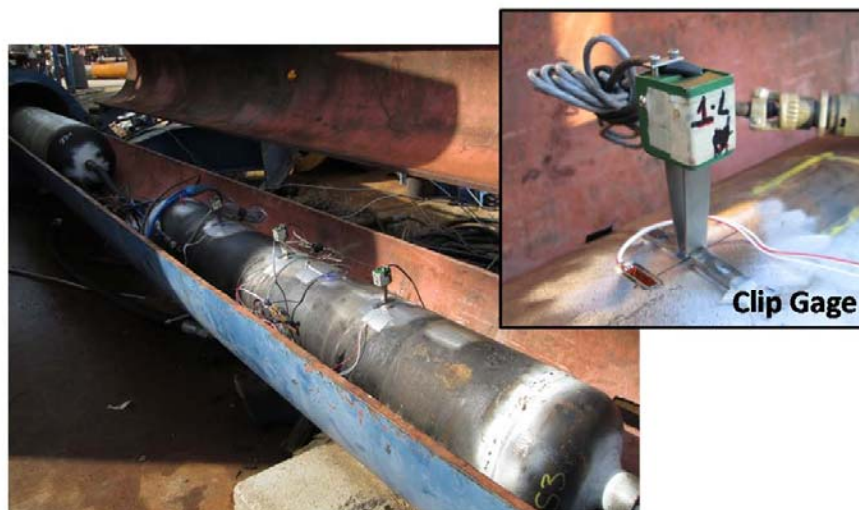
Figure 7: Photograph of Clip Gages on Unreinforced Samples

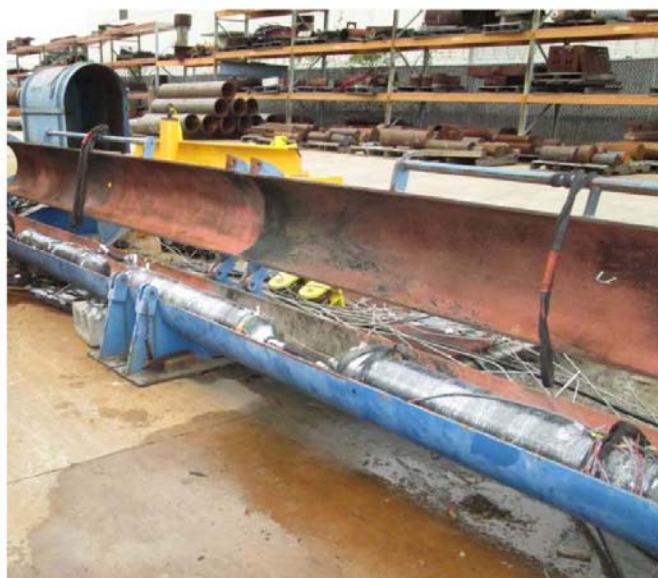
Figure 9: Photograph of Pipe Samples Installed for Pressure Cycling

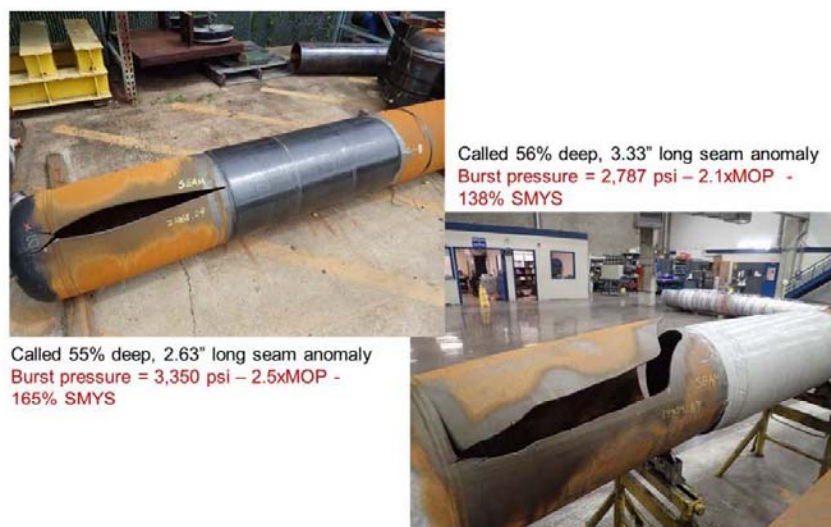
Figure 14: Photos Showing Burst Tests of Actual Reinforced Seam Planar Defects

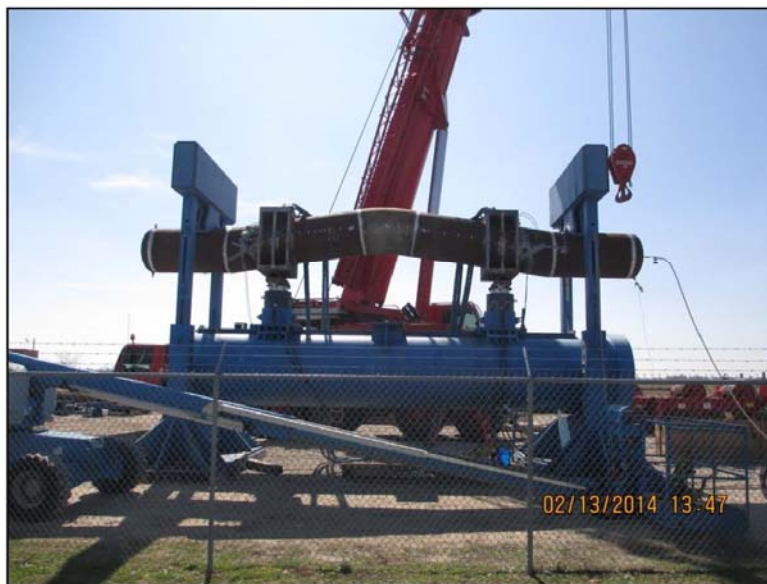
Figure 7: Unreinforced sample on bending beam in CLOSE mode

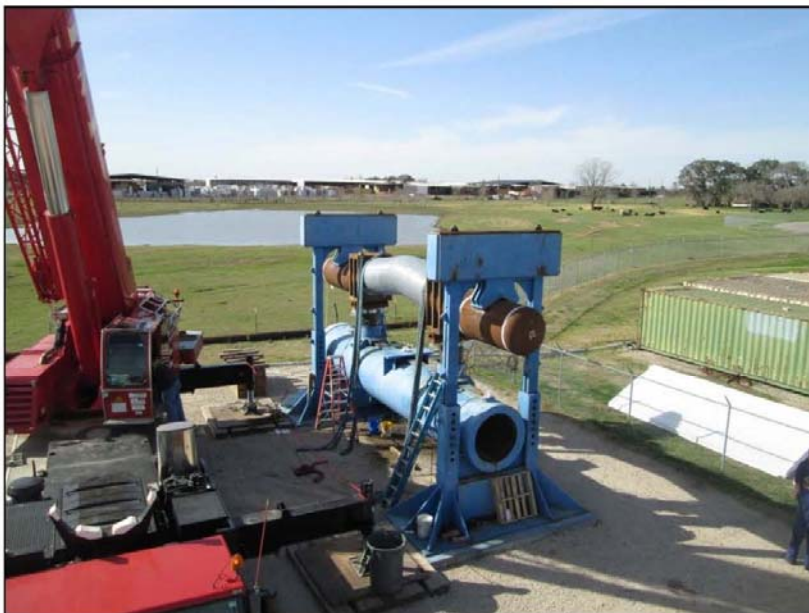
Figure 9: Aerial view of reinforced sample in bending load frame

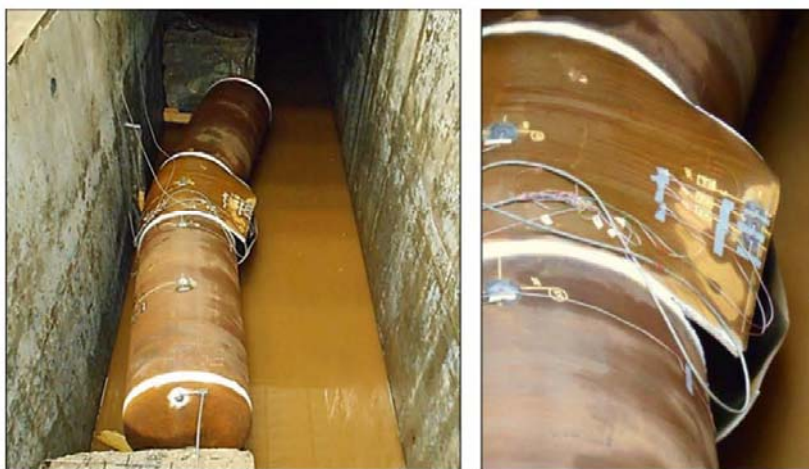
Figure 10: Burst test failure of unreinforced elbow sample
